Potential Failure Mechanisms For C/C-SiC Components

Randy Lee August 2008

Marshall Space Flight Center

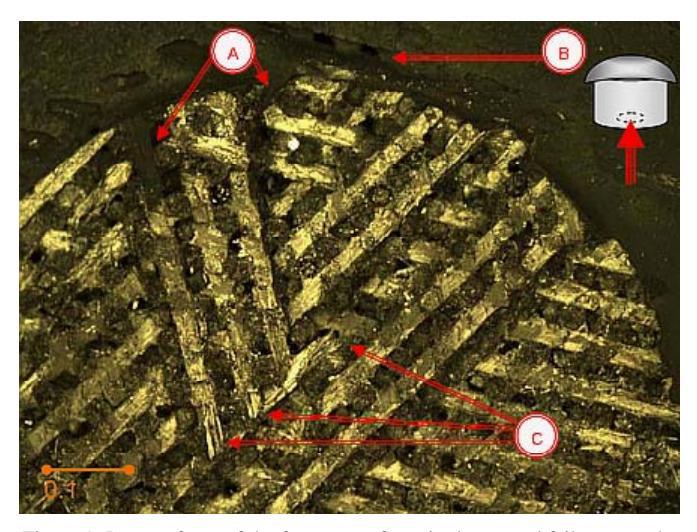
Evidence that the machining process damaged the pintle article is given by the image taken of the HT-7 shaft-to-head fracture surface (so called failure #2) showing that the seal coat material (a slurry of SMP-10 preceramic polymer, fine SiC particles and surfactants), which was applied after the primary and most aggressive machining operations, penetrated into the interlayer spacing between *u*-*v*-*w* layers. This image was given in ATK's Failure Investigation Report as well as in the more recent paper generated by the author. It is duplicated here again for reference in Figure 1 below. The region of slurry penetration is indicated by the red arrows of item 'A'.

Figure 1. Image of one of the fracture surfaces in the second failure near the shaft-to-head interface

This penetration had to occur in a separated or highly weakened u-v interlayer region and not just within the existing composite porosity. Furthermore, the fact that the seal material is visibly apparent on the post-fractured surface strongly implies that the seepage contributed to the fracture, specifically during initiation of the fracture process. Machining is common practice for most composite structures and some of the more modern methods include machining to size and dimension via water-jet, laser and precision CNC. However, many ceramic materials are still machined the old fashioned way via grinding, sanding and sawing. Due to their brittle nature, ceramic materials are particularly vulnerable to machining damage. With any approach however, careful planning

which fail at a later time when the appropriate forces are applied and/or they become permeable to the outside as was the case for the second HT-7 failure shown in Figure 1. Again, these descriptions apply to layered or laminated composites in general but they are particularly relevant to composites containing brittle matrices.

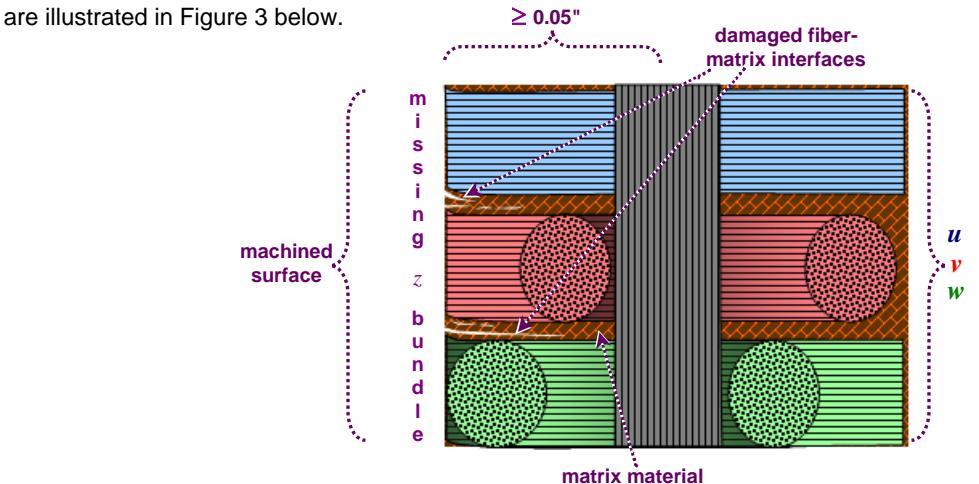
Additional evidence of machining damage can be seen in other shaft cross-sectional views which reveal z bundles machined through to varying degrees. The extent of this damage on the HT-7 pintle has been well documented and visually confirmed in previous communications. There is no denying it, machined z bundles along the z surface of the article (the shaft direction) represent weak areas which are prone to failure. The more tow that has been machined away, the more weakened is the z directional reinforcement . . . and the z bundles are supposed to provide the composite's primary tensile strength component along the shaft direction. The nearest z bundle to one that has been completely removed is at least 0.05" away. Surfaces in which the z reinforcement has either been drastically reduced or completely machined away represent some of the weakest regions in this particular C/C-SiC system. There is evidence that areas exist on the machined pintle shaft in which two or more adjacent circumferential tows have been completely machined through. Without a doubt, these are extremely weak areas. Couple this with weakened u-v-w planes as iterated above and the most prominent failure initiation sites along the circumferential shaft surface can easily be identified (before the seal coat is even applied). Some of these details

Figure 3. Illustration of likely *u-v-w* interlayer and z bundle damage generated as a result of machining operations.

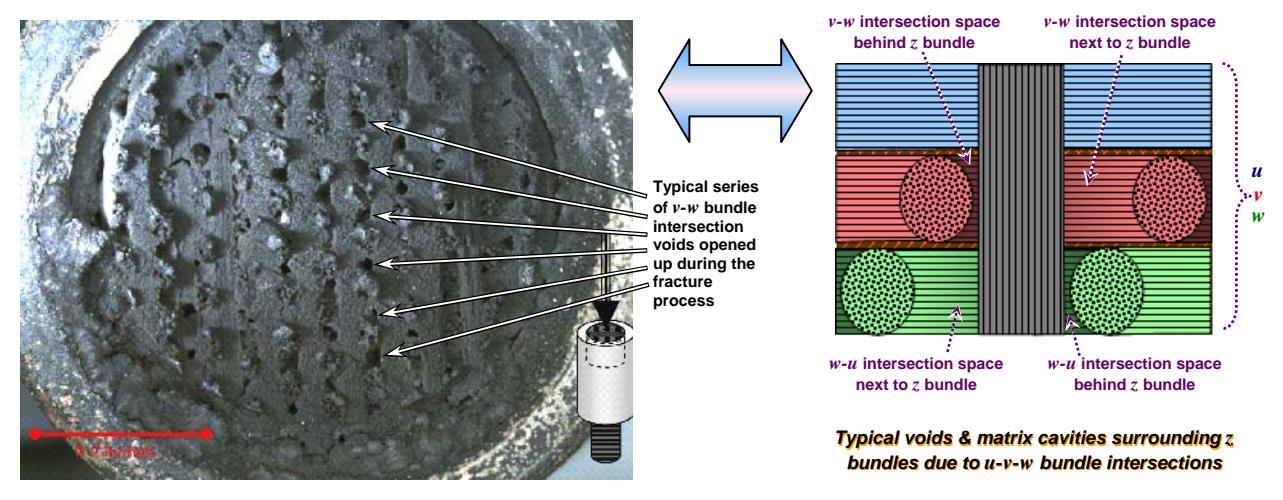
Evidence for the existence of undesirably high levels of localized porosity, voids and cavities that were inadvertantly closed off, sealed or otherwise impervious to the densification fluids is provided again, by previous studies evaluating the failed HT-7 failure. Specifically, the fracture surface on the thread side of failure #1 reveals this localized porosity quite well. This image is duplicated in Figure 4a and contains an excellent representation of the spaces/voids associated with u-v-w fiber bundle intersections as illustrated in Figure 4b (a 'u+90' direction exaggerated for detail). If the top layer of bundles shown in 4a is designated as the v layer then the apparent 'holes' must represent the void spaces under the u layer at v-w bundle intersections as illustrated 4b . . . except the void spaces in the actual HT-7 fracture surface are apparently absent of matrix material. In actuality, some of these holes are due to fiber (bundle) pull-out which will be addressed later.

Figure 4. (a) Thread side of the first HT-7 failure showing apparent layer of porosity/voids present at the fracture interface due to unfilled *v-w* bundle intersections; (b) Illustration of preform structure showing typical spaces and cavities associated with *v*-w bundle intersections.

While this level of porosity is surely not characteristic of the entire composite structure, it is, at the very least, prevalent in localized regions of the material . . . it was definitely present at this fracture interface as indicated in 4a. It is entirely possible that additional layers of voids are present but unseen just below this layer. It is important to realize that these voids were not generated during the burn cycle or the fracture process, rather, they were opened up during these processes and were actually formed during the composite manufacturing (densification) process. They are believed to be part of the 'closed' porosity portion of the total porosity/void volume fraction which were unveiled during the fracture sequence. In addition, they are considered to be responsible, in part, to the root cause of the fracture, particularly why the failure occurred at this particular planar region. These voids are probably localized to this region (further evidence for localized density/porosity variation in this material will be given shortly in Figure 5). If such porosity were present in all or most of the u-v-w layers, the total porosity of the composite would be on the order 40-50%, and much of this would be permeable to the Archimedes porosity/density test fluid resulting in a measured open porosity fraction significantly greater than the reported value of ~13%. The probability that this porosity was localized to this region is a reflection of the material variability. There are likely other areas or planar sections containing similar arrays of voids which are vacant of matrix material, perhaps those associated with w-u bundle intersections (under v layers) and u-v intersections (under w layers). Certain NDE methods may detect these voids to a degree, perhaps x-ray or high resolution ultrasonics. In any case however, these highly porous layers cannot be ignored since they represent weakened mechanical properties (they are present from the core of the substrate all the way to the surface) and they can definitely play a major role in subsequent fractures of the article.

The exact cause for the excessive level of voids generated in Figure 4a cannot be ascertained at this time. However, it is important to realize that these regions or layers of formerly closed porosity/voids were produced during the first or second SMP-10 densification cycle and became permanently sealed off (impervious) from that point on . . . the densification process was apparently not aggressive enough to open these voids up. A preliminary review of the manufacturing parameters and conditions used to produce this billet has already been issued with the conclusion that too few 3000°F heat treatment steps were applied to effectively open up and interconnect all the available the pores and void spaces. It is also suspected that mediocre impregnation techniques may have been employed.

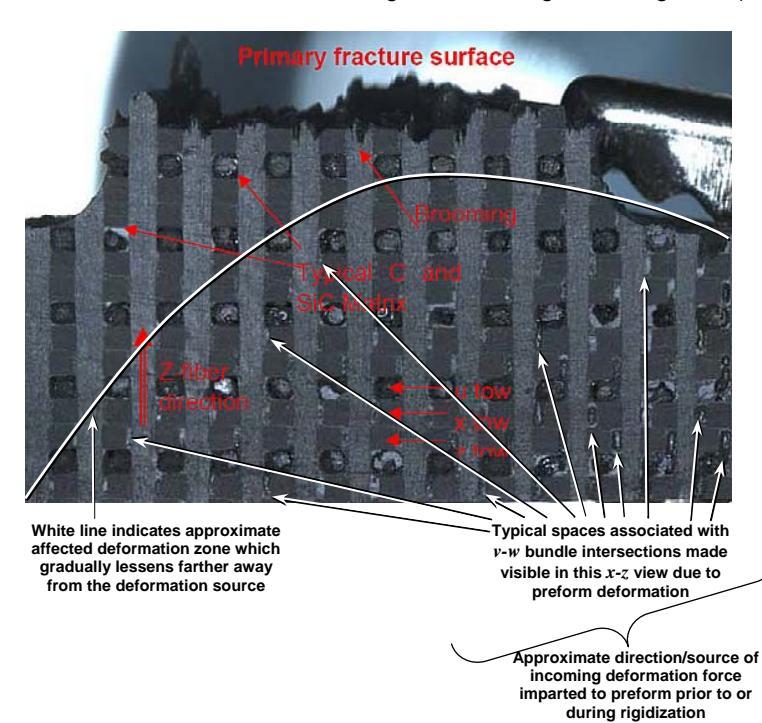
Figure 5. Cross-sectional view of the shaft side fracture surface looking down onto the x-z plane. Emphasized here are details associated with an apparent deformation that the dry preform experienced before or during the rigidization process.

report and is rehashed here to examine more closely the nature of variability introduced into the dry preform before any C/C or SiC densification cycles were applied. Red indications are remnants from ATK's analysis. The view looks down into the x-z plane (that is, a 'u+90' direction, similar to that given in Figure 4b). White arrows indicate an array of filled or partially filled voids/cavities associated with v-w bundle intersections which have been exposed due to an apparent deformation in the preform (prior to densification processing). The deformation seems to have been imparted in a direction coming from the bottom right region of the image causing them to become visible in this view (v-w intersection cavities are most apparent when looking in a 'u' direction, that is, on to the x-z plane). The deformation may have twisted the preform or otherwise opened up the affected v-w cavities by altering their volumes and shapes accordingly.

A combination of apparent fiber bundle pull-out (moderate interface bonding) and crack propagation directly through the bundles (strong interface bonding) seems to be prevalent across the fracture surfaces of failure #1. However, the latter factor might exhibit a slight dominance (as indicated in Figure 5) implying that crack propagation directly through the bundle occurred in a substantial number of the crack-to-bundle encounters (i.e... Path A). This would support previous data and conclusions reflecting the impressive level of apparent fiber-to-matrix bonding throughout the body of the pintle. It also implies that the *z* fibrous reinforcement provided less-than-optimal benefit or advantage to the composite in this particular failure. And there is no reason to believe that this mechanism/path is localized just to this region of the material . . . It may be representative of the overall mechanical behavior relative to the reinforcement throughout the entire body. This would be indicative of the unduely low fiber volume fraction in the *z* direction (or spacing between bundles; both reflect the same property).
