Field Corrosion of 212 Main Rotor Blades – Analysis of EDX Results

Bell Helicopter Textron

Assembly & Rotors, Design Quality & Engineering

May 2005

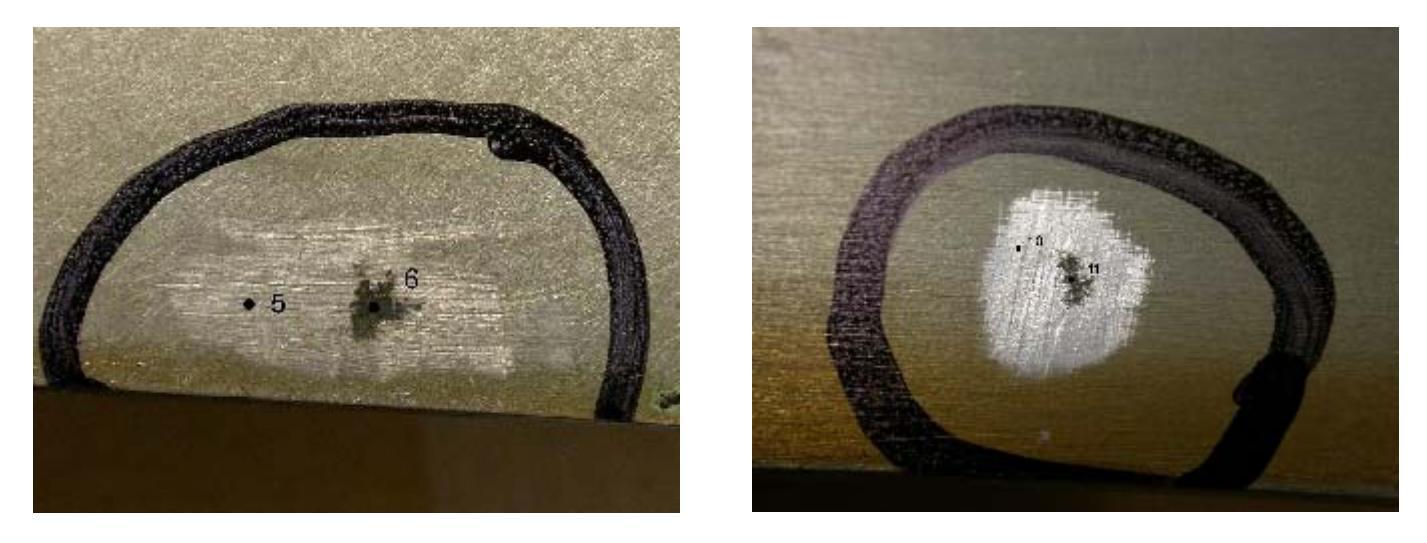
Figure 1 Areas of apparent corrosion exposed after coating removal via plastic media blast; Left image A-5361, Right image A-3434.

These photos indicate probable corrosion spots, black or dark gray in color, which had apparently been growing under the coating. Pitting is also characteristic in these areas as well as most of the other samples studied previously. It is also obvious that mechanical abrasion (sanding) has been performed on these areas at some point in their history, supposedly during repair/rework procedures. Concurrence with authorities in the Bell rework and repair departments confirmed that this work was not performed in-house either during normal manufacturing or field return rework operations. Therefore, it was concluded that these sanding patterns were most likely the work of outside field repair technicians serving the end customer. It is strongly suspected that field technicians noticed numerous spots such as these, suspected of being corrosion, after removing most or all of the coating from the blade during field shop processing for repair of the corrosion spots reported earlier. Furthermore, it is believed that these spots were much smaller at that time and have significantly progressed since then. In all likelihood, the technician(s) saw these 'spots' as small aberrations and swiped a sanding block across the areas a few times prior to re-painting. It is suspected that field repair personnel may have employed less-than-adequate techniques during their repair operations. Another perspective concerning the field repair operations will be noted later. However, it should be kept in mind that poor field workmanship (if factual) is not the cause of the initial corrosion conditions.

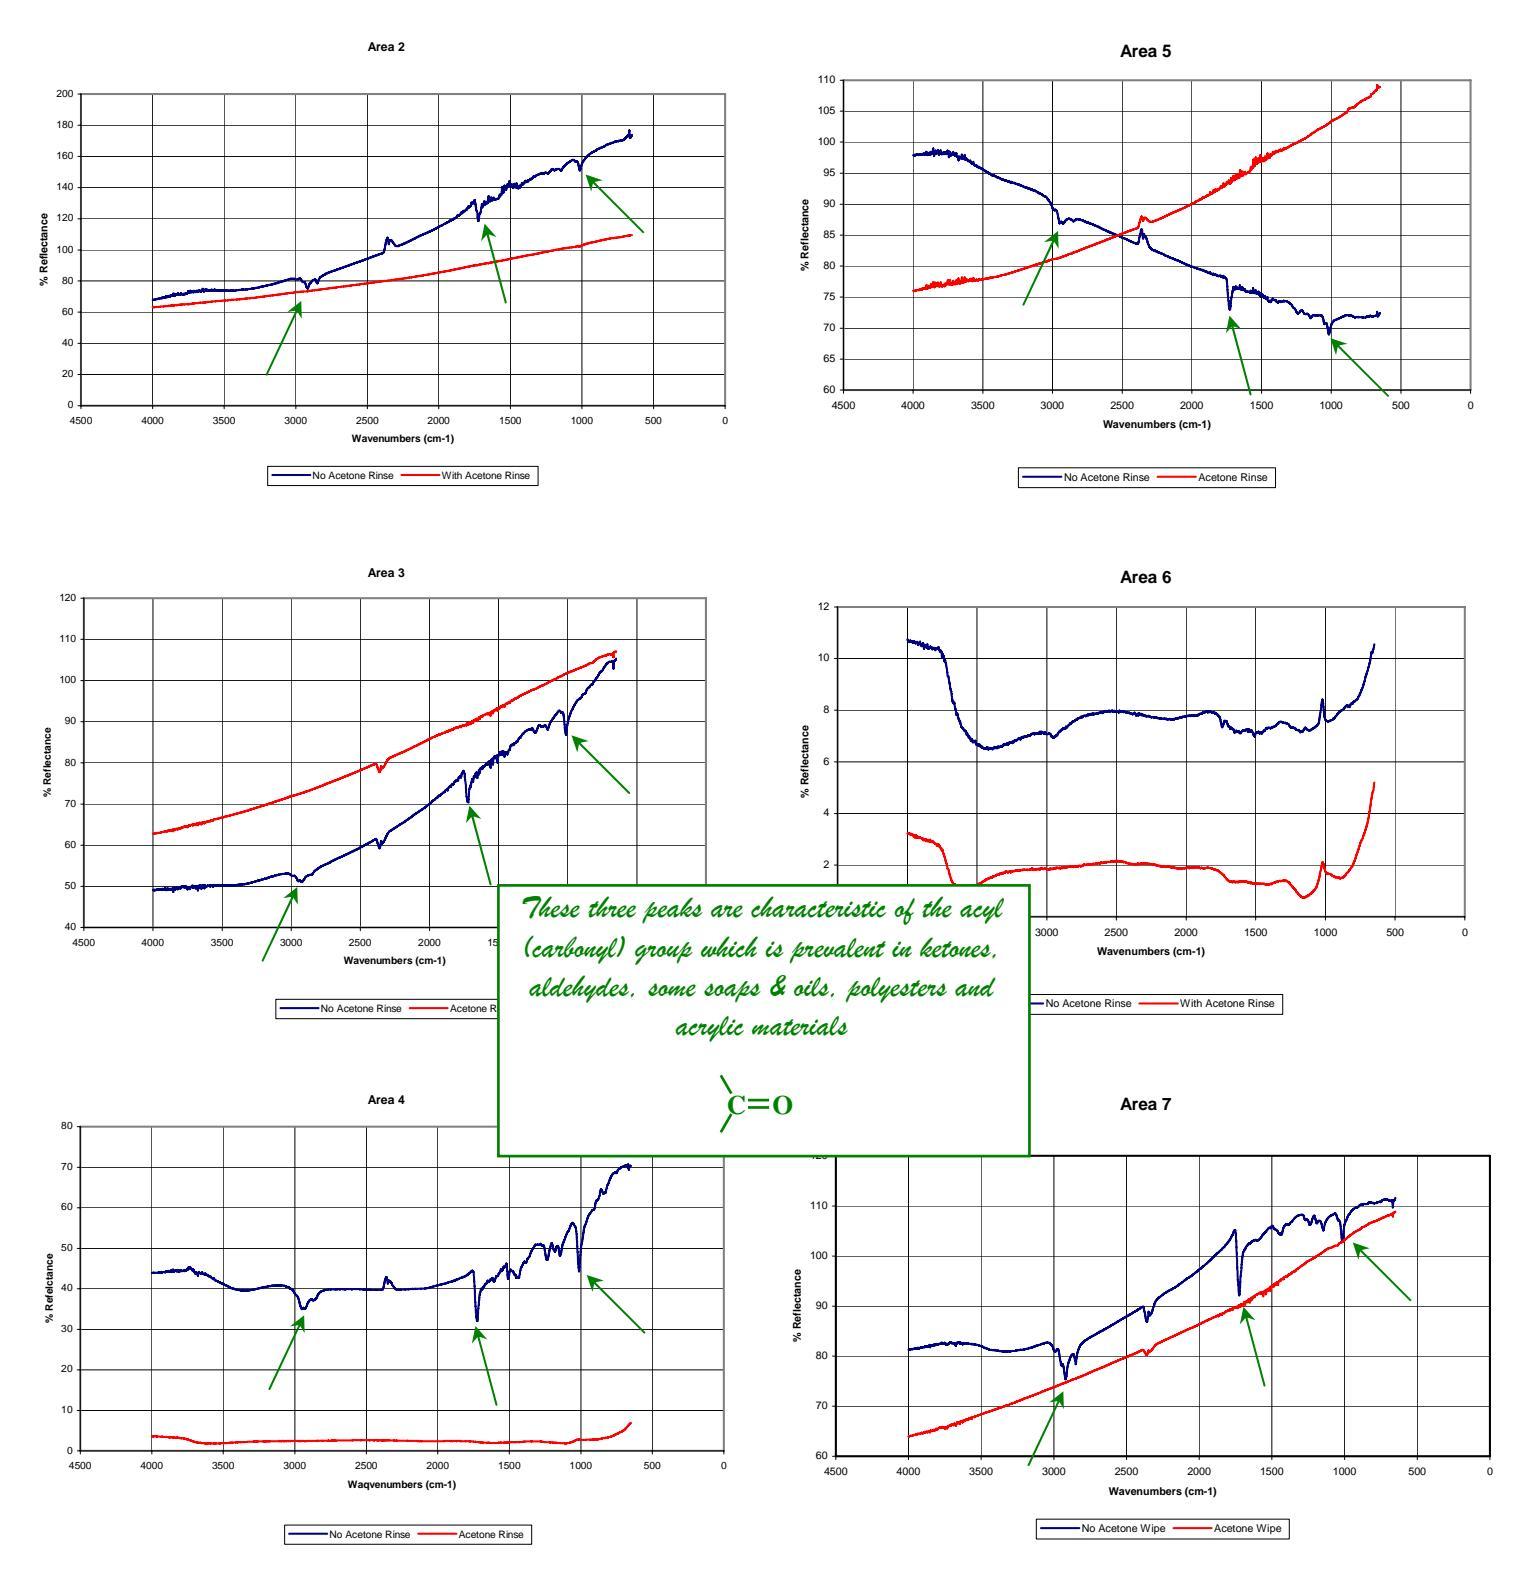
There were questions regarding the nature and quantity of carbon indicated in most of these tests, in particular, whether the carbon was organic or inorganic in form. Subsequent to the initial EDX work, Chad Ford was kind enough to perform an acetone wipe on some of these sample areas and have the Organics Lab perform FTIR analysis of the washed sample surfaces prior to performing a post-wash EDX of the sample areas. FTIR results from those tests are given in Figure 2 along with some comments inserted by the author.

Figure 2 FTIR spectra of bare and corroded samples before and after acetone wipe.

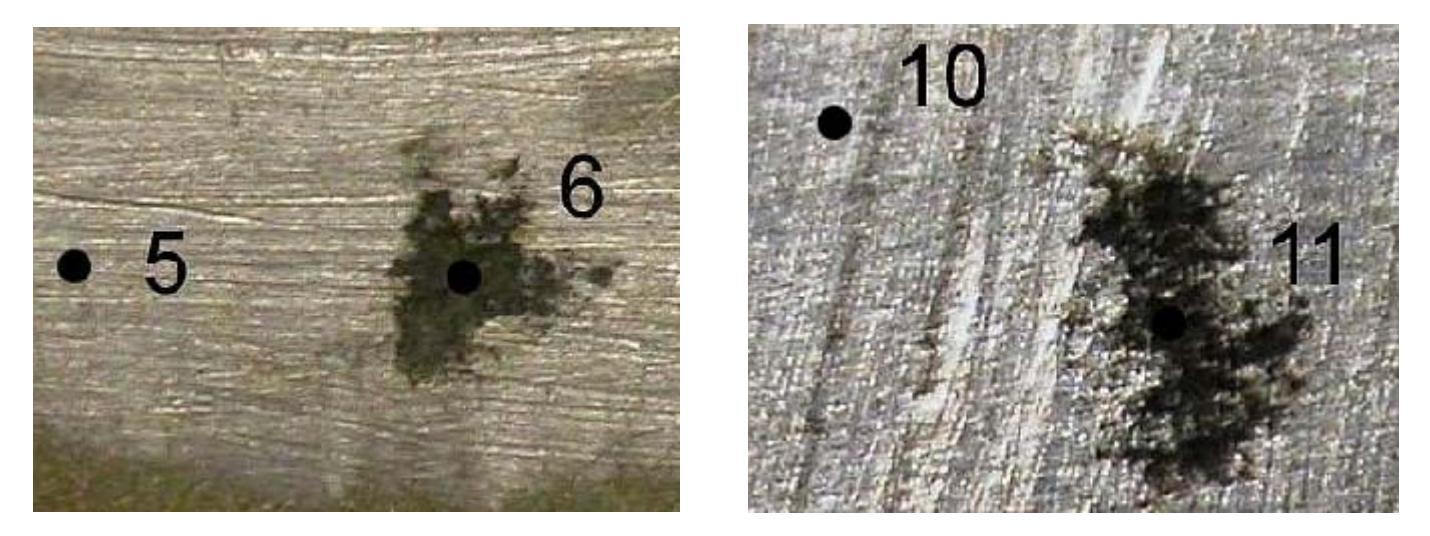
Figure 4. Magified views of corroded sample areas after media blast, as taken from Figure 1.

While it is likely that remnants of white corrosion products could have been removed and blown away during media blast, these obvious darker corrosion effects have not been accounted for. Traditional theories dealing with aluminum corrosion almost always include formation of hydroxide and oxide precipitates as noted above. Contrary to more popular mechanisms which tend to follow classical thermodynamics (such as the Nernst equation), dissolution of cathodic Cu-rich particles followed by their oxidation to black copper oxide is believed to be quite possible. On the other hand, in situations where the intermetallic phase is rich in Mg, the mechanism dipicted in Figure 3 is essentially reversed and no degradation of the Al will occur. Rather, the Mg-rich granule will itself begin to dissolve since it is anodic to the surrounding Al matrix. Some of the intermetallics which are likely to be more active than (anodic to) Al, would include compounds such as Al₂CuMg, Al₃Mg₂ and Mg₂Si, all of which could raise the local potential high enough to induce corrosive reactions. Many of these Al-rich/Mg-rich anodic intermetallics also contain Cu to varying degrees which will dissolve in the local solution and oxidize, deposit or precipitate somewhere in the vicinity.
