Potential Failure Mechanisms For C/C-SiC Components

Randy Lee August 2008

Marshall Space Flight Center

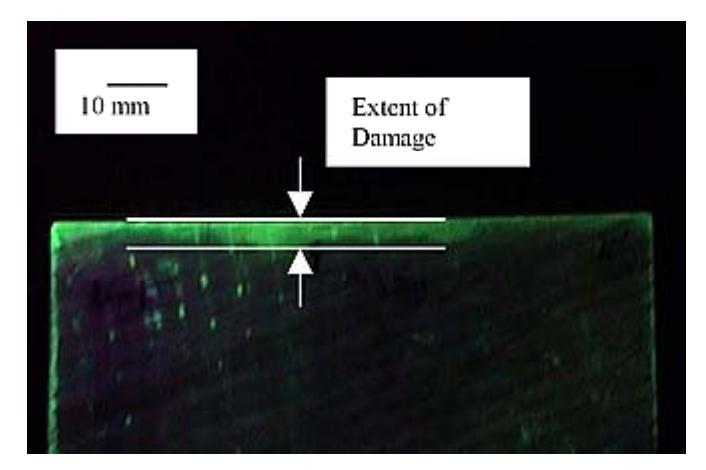
The extent and depth of the damage zone are expected to be notably higher for brittle ceramic matrix composites. Machining of surfaces in which the plies are parallel to the surface are less severe since interlaminar damage is minimized (interlayer in our case). However, surfaces in which the plies (or layers) are perpendicular to the surface are highly susceptible to interlaminar/interlayer fraying-type damage which permeates into the substrate body and comprizes the damage zone. This zone of weakened planes and separated layers is a result of mechanical interlayer damage which markedly reduces the fiber-to-matrix bonding properties in the damage zone. The effects are often manifested as latent debonds or microseparations between weakened planes (layers)

Figure 2. Machined surface after dye penetrant test on a glass fiber composite. Taken from, "Secondary Processing of Polymer Matrix Composites"; Inderdeep Singh, Debasis Nayak, Naresh Bhatnagar; Department of Mechanical Engineering; Indian Institute of Technology Delhi, New Delhi, India-110016.

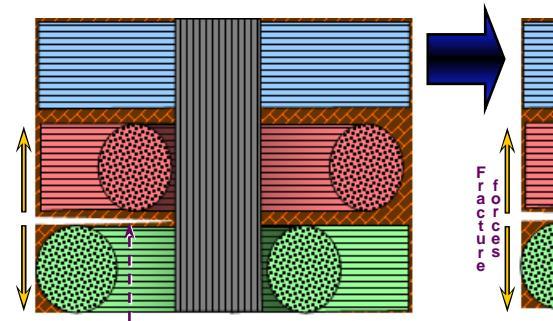
Fracture initiates at a weakened v-w bundle/lave interface and propagates along or parallel to the fiber-matrix interface

The fiber-to-matrix interface

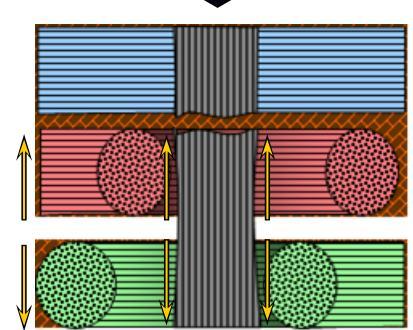
Fiber bundle breakage occurs upstream from the fracture front and begins to bridge the fracture gap

progressive pull-out toughen the region as the bundle continues to bridge the joint

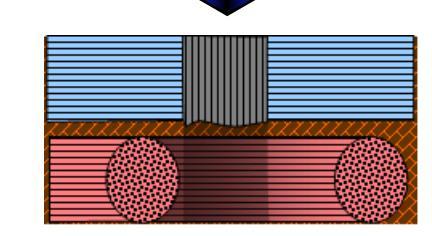
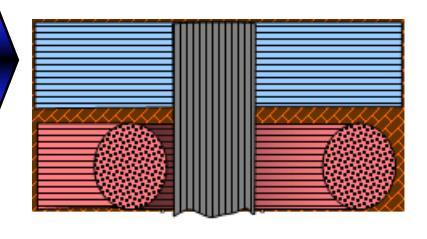
Bundle rupture occurs depending on fiber-tomatrix bonding and fiber properties. Path A represents a condition in which the reinforcement provides little benefit.

Path B (the toughening process): If the extent and strength of fiber-tobonding matrix is moderate, energy will be transferred into the formation of debonds perpendicular to the progressing crack (fiber-tomatrix debonds above and below the crack). In this case, the rate of progression of the fracture is temporarily 'delayed'. As the matrix on the other side of the bundle begins to crack, the bundle is still capable of transfering load across the crack surfaces in an effect referred to as 'fiber bridging'. When the bundle finally breaks (usually away from the fracture plane), the crack continues to advance but bridging allows the fiber bundle to continue carrving some of the load. Here, fiber-to-matrx frictional forces. continued debonding and bundle pull-out absorb more fracture energy which greatly enhances the toughness level of the composite. Thus, the CMC toughening mechanism begins with the fiber bundle bridging stage and continues to function beyond pull-out finally breakage until occurs.
