Field Corrosion of 212 Main Rotor Blades – Analysis of EDX Results

Bell Helicopter Textron

Assembly & Rotors, Design Quality & Engineering

May 2005

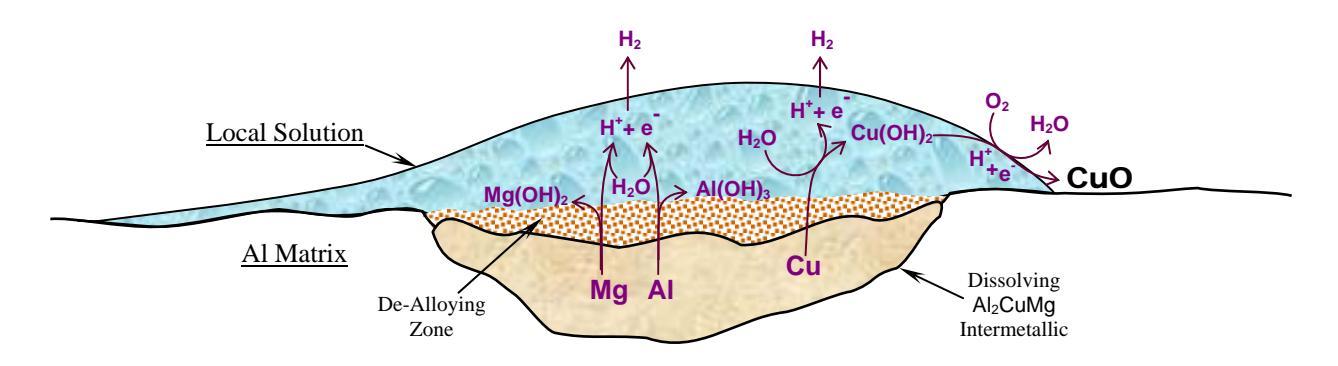
In this situation, the intermetallic phase acts as the anode (producing electrons) while the AI matrix in close proximity to the activity becomes the cathode. Hydrogen gas is evolved throughout the process. Graphical representation of the proposed scenario, using Reactions (9) and (10), is illustrated in Figure 5.

Figure 5. Galvanic couple between Mg/Al-rich intermetallic and Al matrix with the production of black copper (II) oxide.

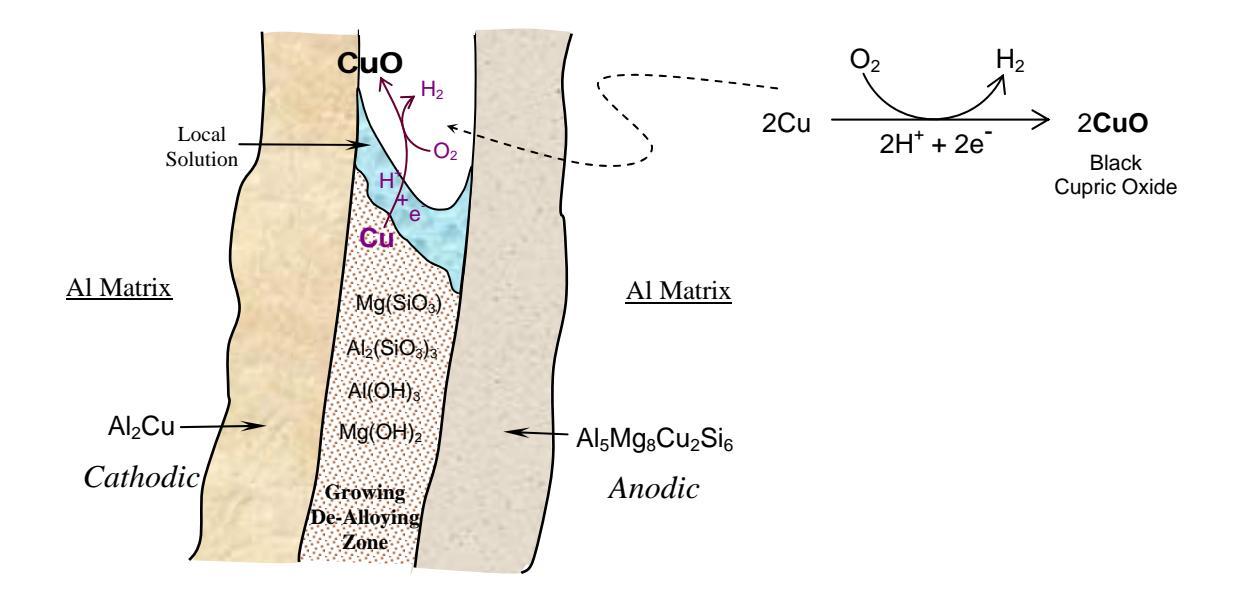
Nevertheless, in this situation, certain layers of the boundry will oxidize/hydrolyze resulting in separation of intergranular segments and planes, as well as the production of black cupric oxide which deposits along the drying regions. An illustration of this possible scenario is dipicted in Figure 6.

Figure 6. Illustration of possible intergranular corrosion situation that produces black copper oxide in which the boundry configuration includes interacting layers of cathodic and anodic intermetallic phases.
